# A Long-Term Case Study in Residential Sustainability

Amy F. Heidner, PE Dennis L. Heidner The Rextor Group PLLC

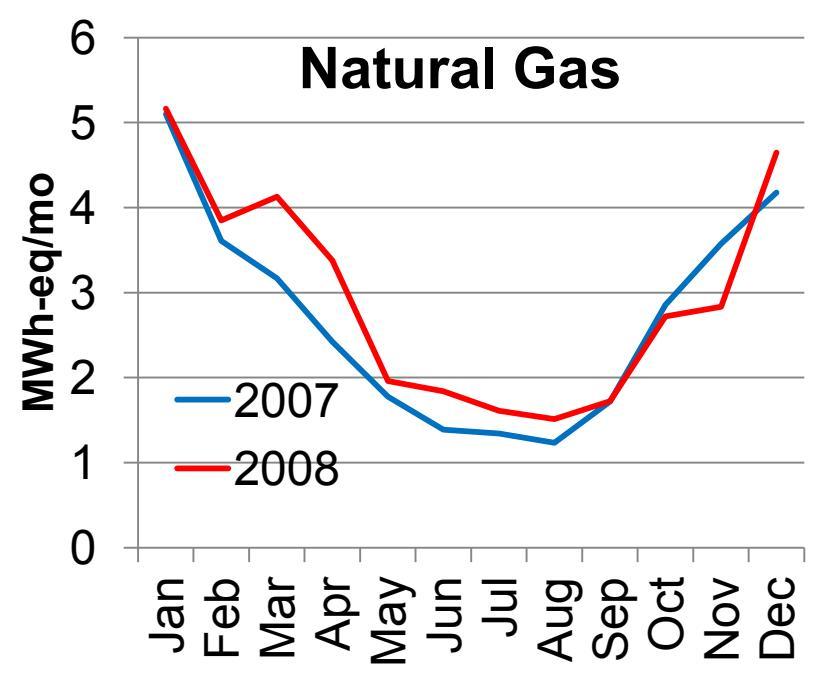
- U-shape as expected for heating climate
- Summer base is water heat, cooking, clothes drying, spa heat
- ~ 15% higher than similar size houses in same urban area using natural gas heat
- Expected a U-shape for heating climate, but ...

- Peak use is summer!
- ~ 95% higher than similar size houses in same urban area using natural gas heat

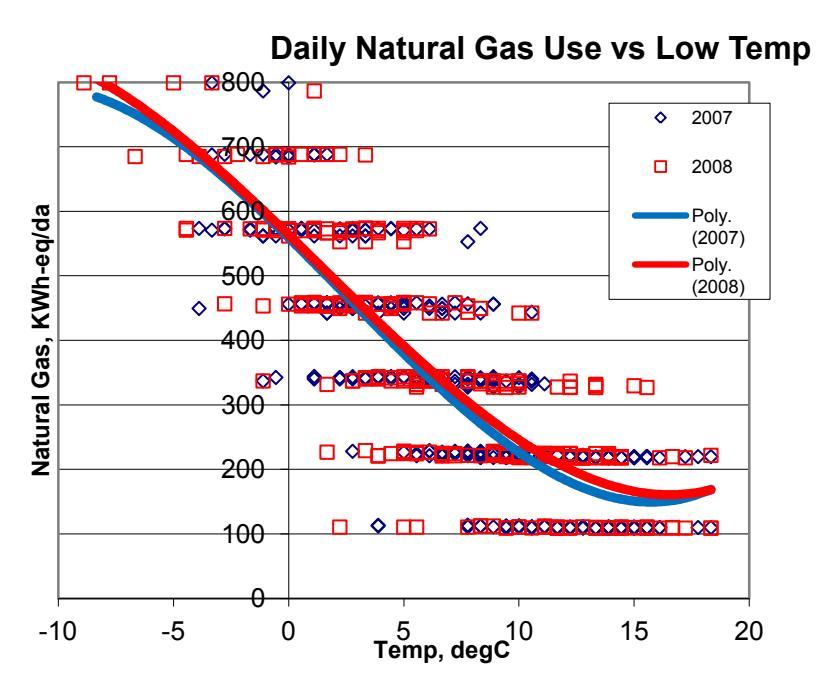
- Summer base is water heat, cooking, clothes drying, spa heat
- Slope at medium temps indicates magnitude of thermal leakage through building envelope

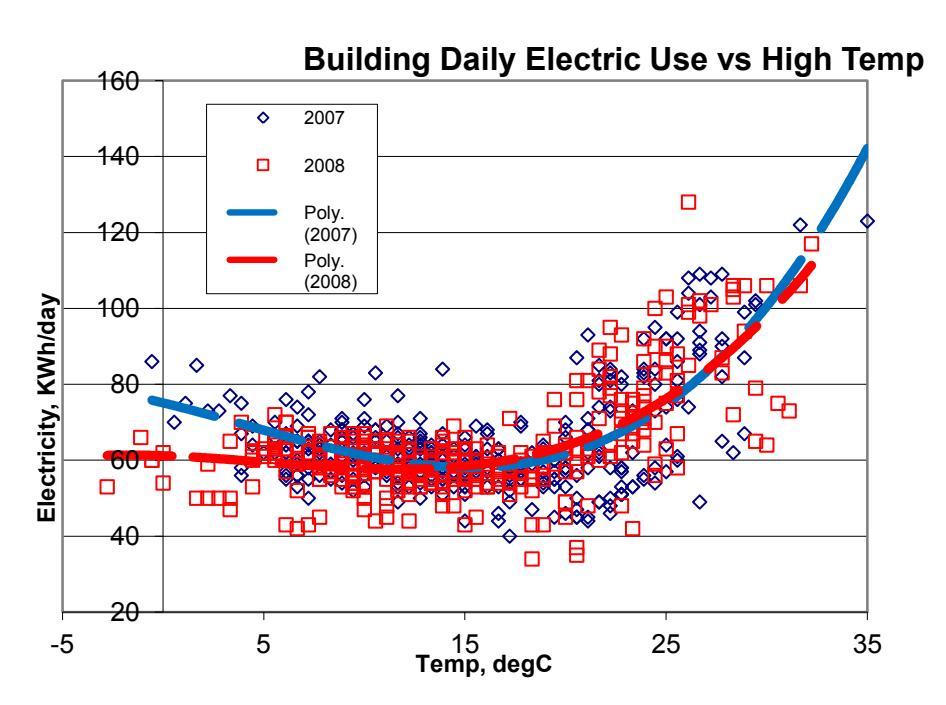
• Expected a U-shape for heating climate, but ... the huge slope for summer is ridiculous!

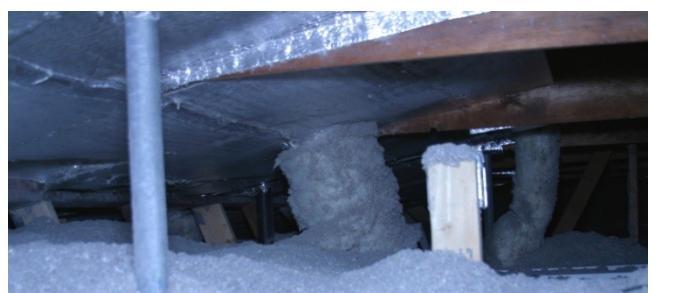
Recessed ceiling lights •Not rated "in contact" •Leak air and heat

14" cellulose insulation blown in (dropped ceiling in center)

Daylight tube connected and insulated, reflective insulation across bottom of rafters

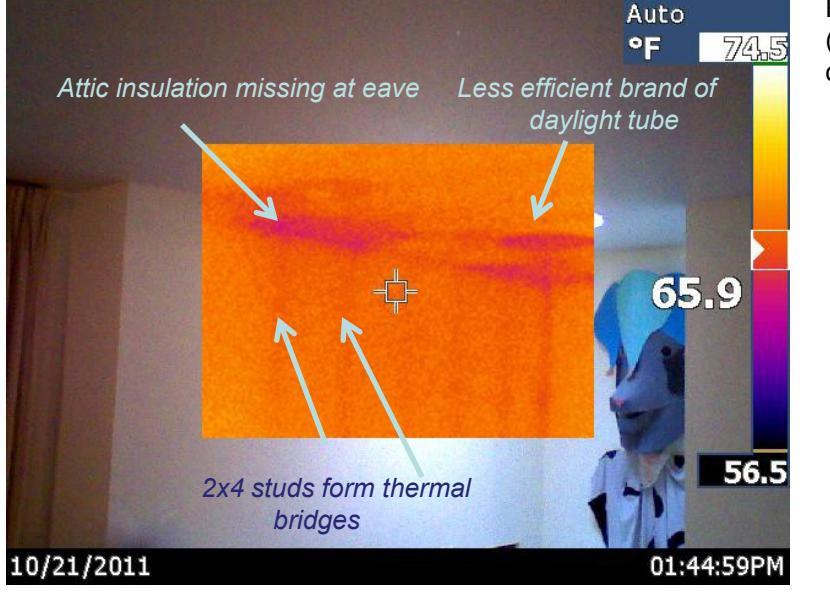
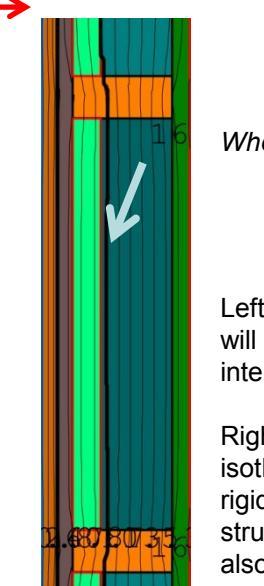
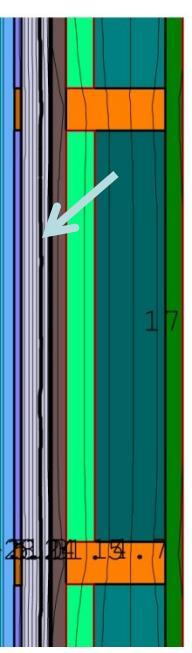
Horizontal cross-section of walls with 2x4 studs:

Left: existing wall, L to R: cedar siding, felt, plywood, cavity, fiberglass, gypsum drywall.

Right: proposed wall, L to R: new siding, drainage with wood spacers, 2.5 cm (1") rigid insulation, drainage screen, house wrap, cavity, fiberglass, gypsum drywall.

Where will condensation occur? At the 6C isotherms (heavy black lines indicated with arrows.

Left, existing wall: Condensation will occur along the fiberglass-air interface *inside* the wall structure.

Right, proposed wall: The 6C isotherm runs in the middle of the rigid insulation, *outside* the wall structure. The rigid insulation is also moisture-impermeable; the actual condensation will occur on its outside surface.

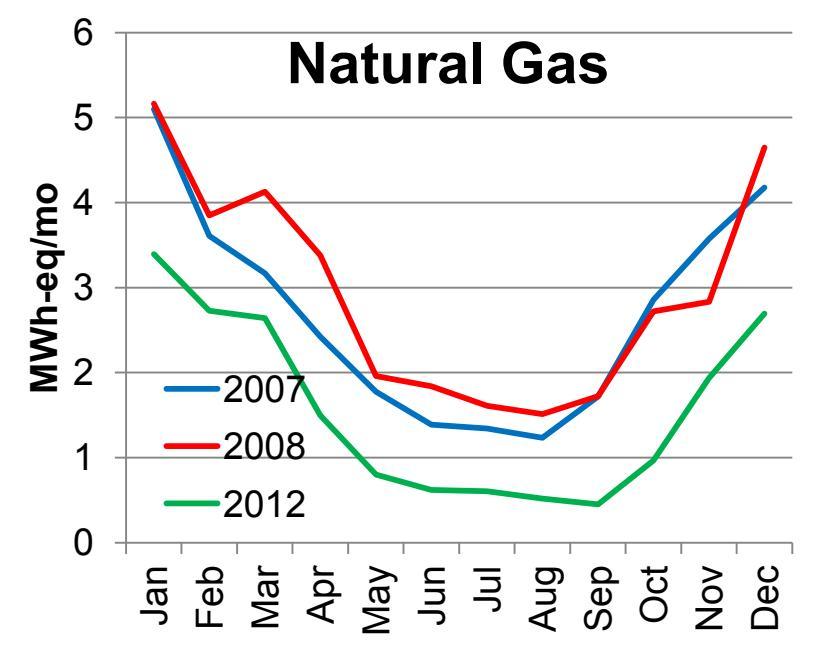
- Base load is reduced
- U-shape is still there
- ~ 28% less than similar size houses in same urban area using natural gas heat

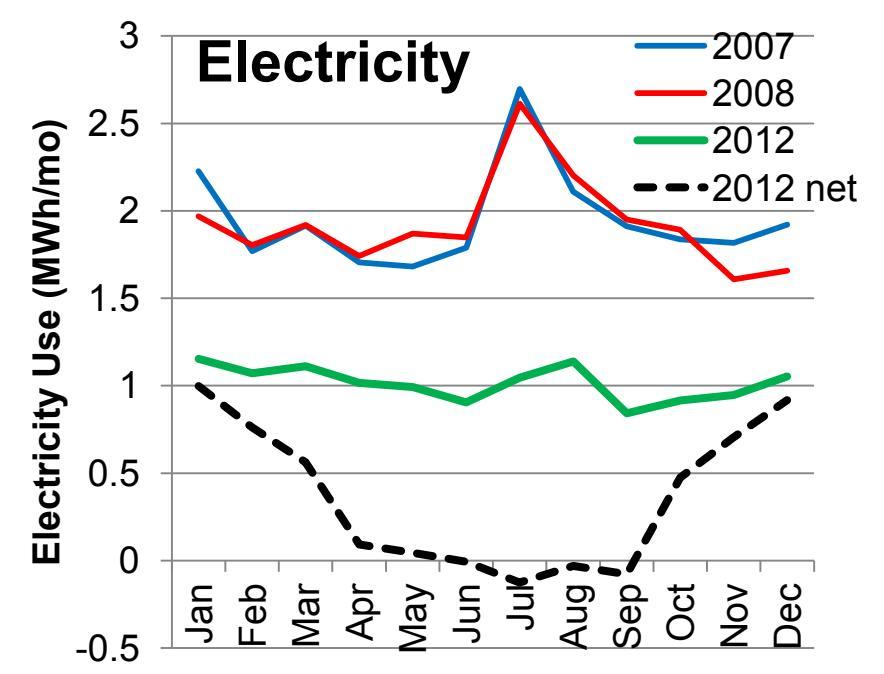
• Use is essentially flat year-round

- ~ 11% higher than similar size houses in same urban area using natural gas heat
- Electric use at US average for 11.2 m<sup>2</sup> (500 ft<sup>2</sup>) house
- PV production reduces amount used from grid each month

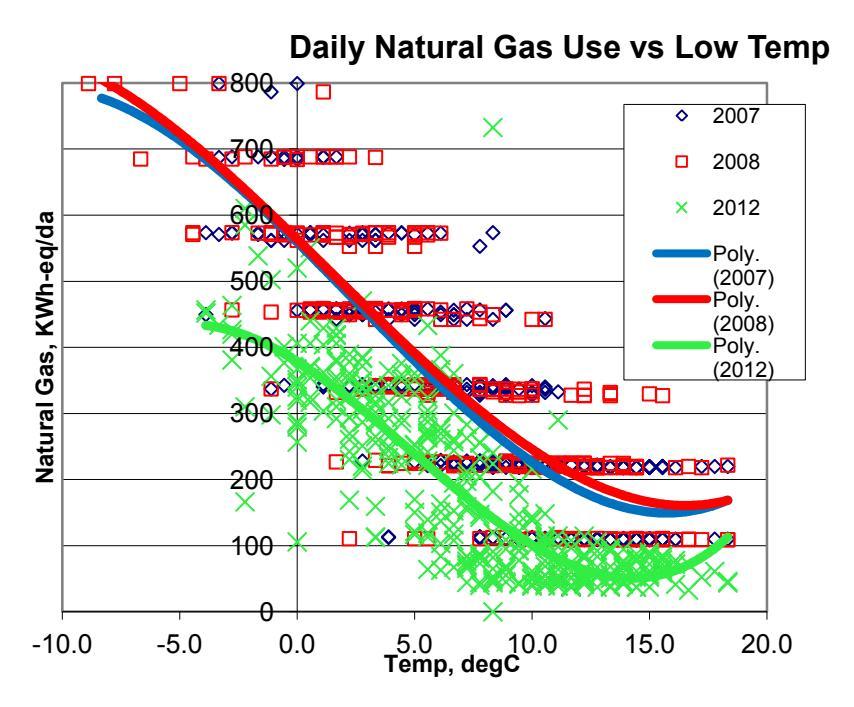
- Summer base has decreased
- Slope at medium temps has decreased slightly

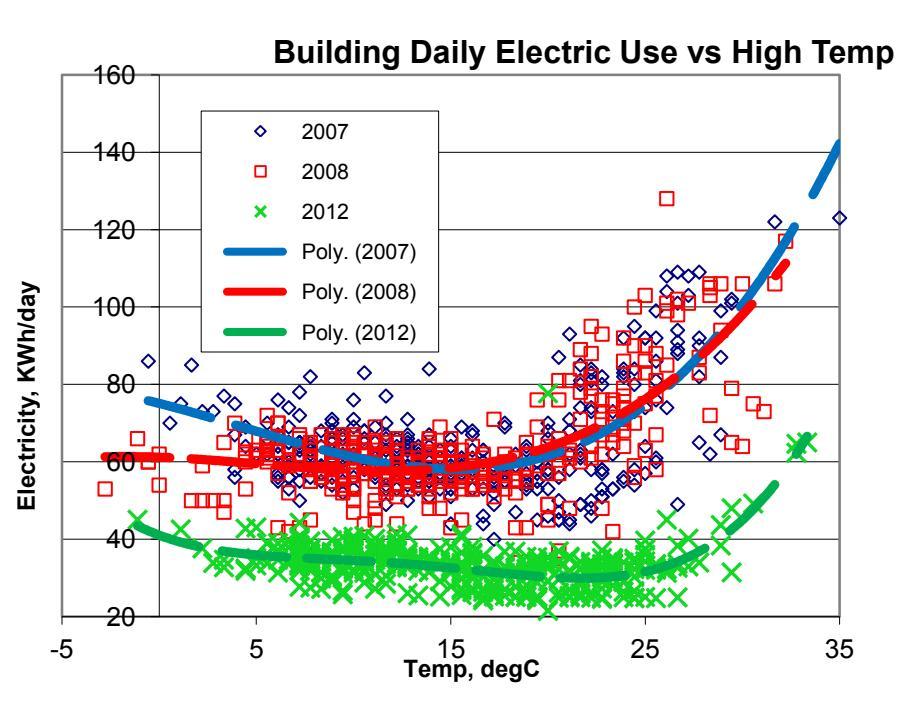
Usage is basically flat year-round except for a few days when Thigh > 30C (86F)

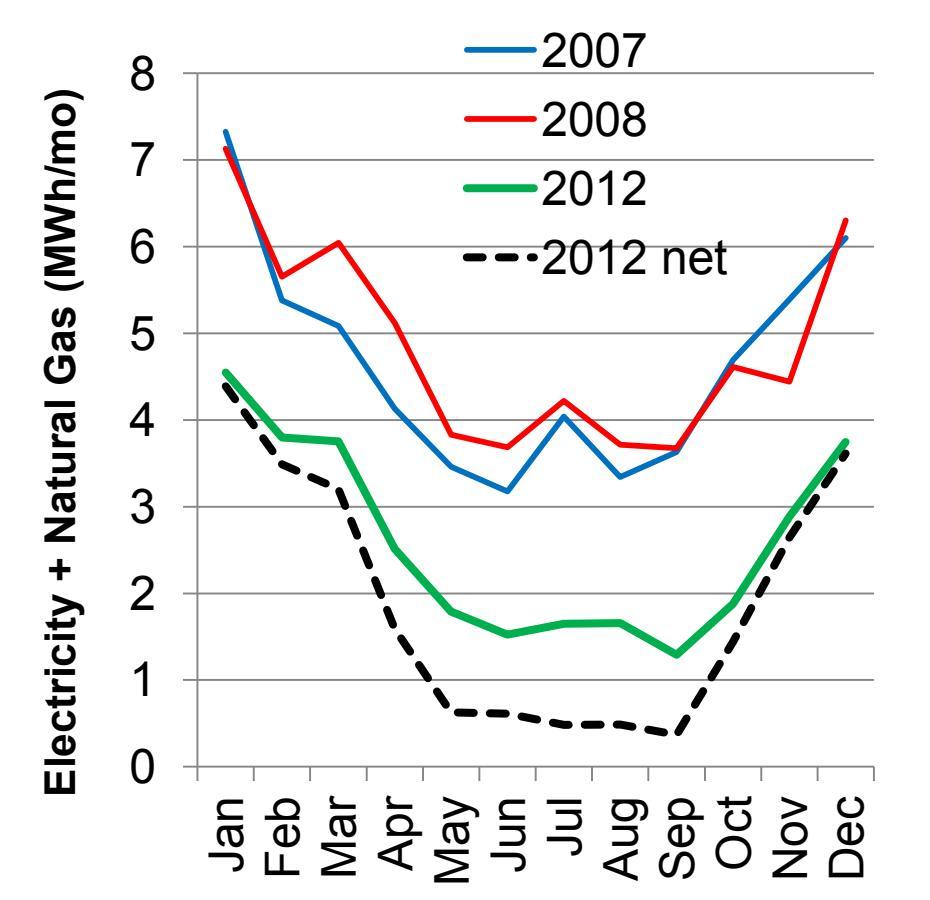
- Summer peak gone
- Energy use still has U-shape for space heating (natural gas)
- Energy use ~ 17% less than similar size houses in same urban area using natural gas heat
- Energy net ~ 38% less than similar size houses in same urban area using natural gas heat
